Oakland M. E. Church (Old Oakland Methodist Church) Mineral Hill Road at Oakland Road

Maryland Historical Trust State Historic Sites Inventory Form

Survey No. CARR-1018

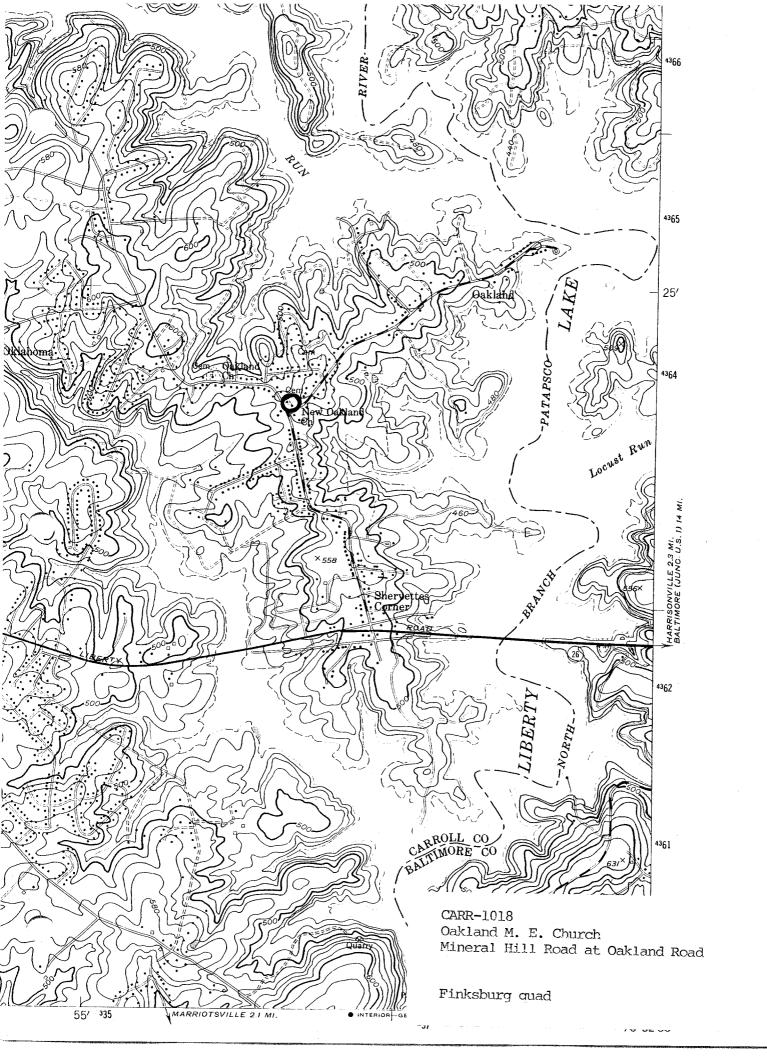
Old Oakland m.E. Church Mineral Hill Rd. at Oakland Rd. Carroll County, maryland Photo: Kennoth m. Short Date: Haril 1993

Nog. Loc. Maryland Historica Trost orth & west elevations

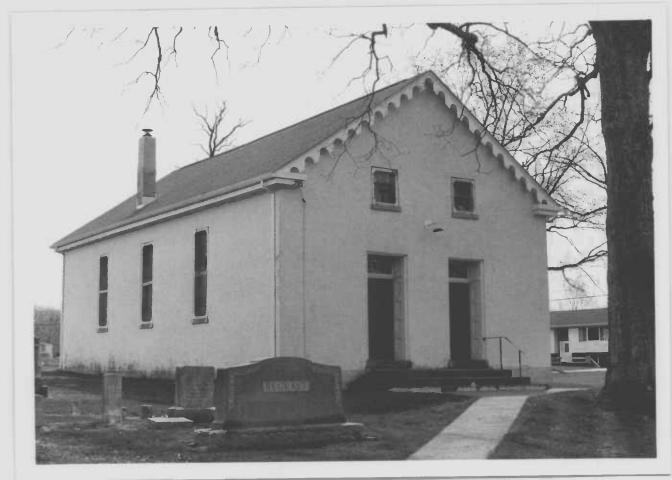
The church is a two-bay by three-bay, one-story structure with rubble stone walls that are stuccoed. The gable roof has asphalt shingles and an east-west ridge. There is a box cornice, now covered with aluminum, with returns. The west elevation has two pair of double doors, with stone sills and a five-light transom above. Between the doors and the transom is an ogee moulding that is carried around on the panelled jambs. The soffit is also panelled. The doors have four panels each. The panels are sunk and have narrow ogee panel moulds, with a small bead on the inside of the ogee. In the gable end are two 3/3 sash with stone sills. The raking eave has jigsawn bargeboards with a saw-tooth type pattern. According to the pastor, there is a datestone with "1860" on this elevation, but it is now stuccoed over.

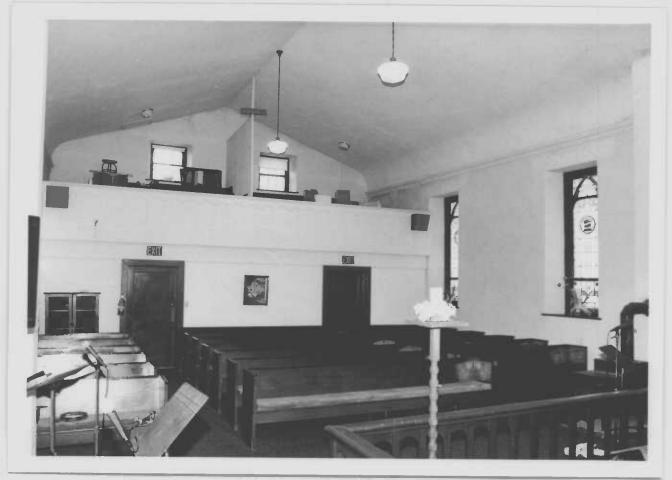
Old Oakland m. E. Churd-Nineral Hill Rd. at Oakland Rd. Carroll County, Maryland Photo! Kenneth m. Stort Date: April 1992 Neg. Loc.: Maryland Historical Trust interior-view northwest

The interior walls are plaster on masonry, and appear to have originally been painted a slate color. The gabled ceiling is plaster, and is coved at the eaves. Below the cove is a run plaster cornice on the north and south walls. It has a torus at the top and bottom, with a cavetto in between. The east elevation has only the top torus in the cornice, while the west elevation has nothing. There is a plain baseboard. The random-width board floors run east-west. The church has a balcony on the west end, with winder stairs in the southwest and northwest corners. The ceiling under the balcony is plastered and slopes down from west to east. The stairs are enclosed with plaster walls, and have a closet underneath them. The closet doors have vertical, beaded-edge-and-center boards, surrounds with a beaded interior edge, and are grained. There are doors on the stairs that match those on the closets, but are painted. The interior side of the front (west) doors are also grained. The interior walls of the stairs have beaded edge vertical boards that were painted a dark olive green. The balcony has an aisle across the front, with three steps up to the west that hold benches.

A later wall with two doors has been constructed under the east end of the balcony to create a vestibule on the west. Two engaged Greek Doric columns survive, partly hidden by the wall; there is one under each end of the balcony. The balcony wall above has broad, depressed lancets with flat, sunk panels. The pews are made of plain boards, topped with a simple flat moulding, and grained. They are set in three columns, with two aisles. On the east end is a raised dais with a three-piece altar rail. The rail has the same gothic motif as the balcony, but is open between the balusters, not panelled. The finish on the rail is deteriorated and it is not clear whether it was grained or simply painted. There is a raised podium for the pulpit, which has since been moved aside. The pulpit is dark pine, with flat sunk panels in gothic arches. Along the east wall are five walnut chairs. Three are from New Oakland M. E. Church, South, according to the pastor, while two are original to this church.

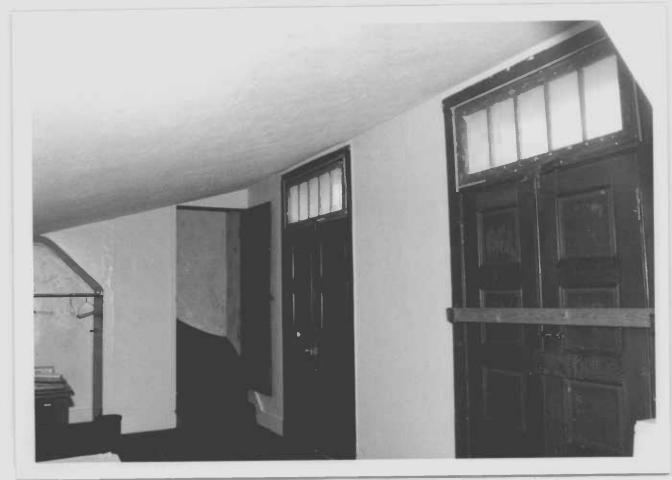
Old Oakland M.E. Church Mineral Hill RQ. at Oakland RQ. Carroll County, Maryland Photo: Kerneth M. Short Date: April 1993

Neg. Loc: Maryland Historical Trost Interior-view Southwest

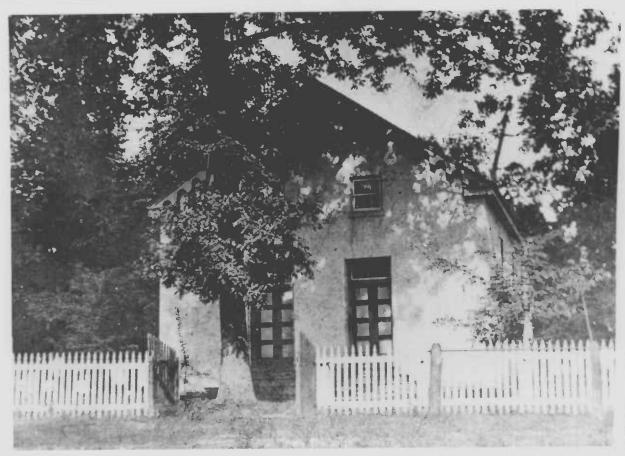
CHER 1018 Old Oakland me. Church Mineral Hir Rd. at Oakland RD. Carroll Courty, Marylana Plato Keneth M Short

Around 1885 the church had the same stucco finish and bargeboards found today, as well as the same front doors; the panels in these doors were painted a light color,

The mention of stone suggests that the building was not yet stuccoed. The stucco is clearly shown on a photograph dated c. 1885, which helps to date this alteration rather closely between 1878 and c. 1885.

Date: 1711 1993 Neg. Loc Morgland Distorion 1 That 1385 Prets

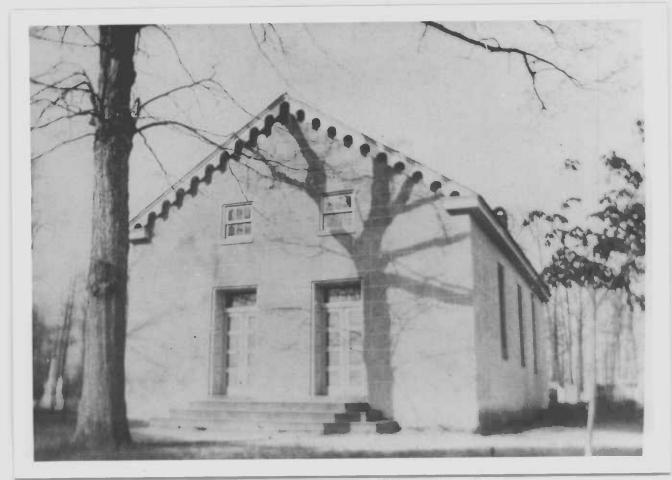
CARR 1018 Old Oakla & ME Chard Miraral Hill read at Oaks & Road Carrott County, Maryland Photo, Kerneth in Short Date April 993 Neg. Loc. Caryland Listorica I Trist C 1900 photo

while the rest of the door was dark. In front of the church was a picket fence. The posts were round uneven logs tapered at the top. The tops of the pickets were decoratively cut, and the tops of the pickets on the double gate were set on a diagonal, being higher in the center than at either end. By around 1900 the stucco was painted a medium color, and was scored or striped to imitate ashlar. The doors and jambs were painted a light color, and now the panels were darker. This changed again by about 1940, when the doors were painted one dark color, and the striping was gone from the walls. By this time the stained glass had been installed.
